Manhole Inspection Summary

Manhole # S35AA2010MH

Location Address: **317 TAPLOW RD**

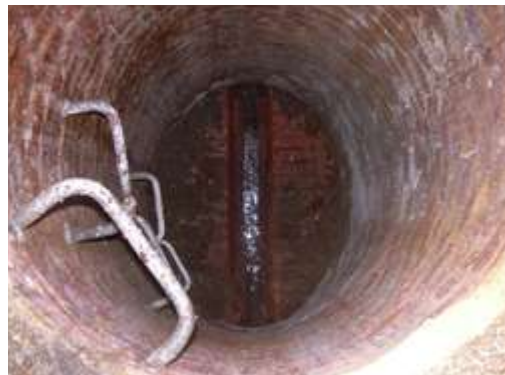
Top View

Bench debris.

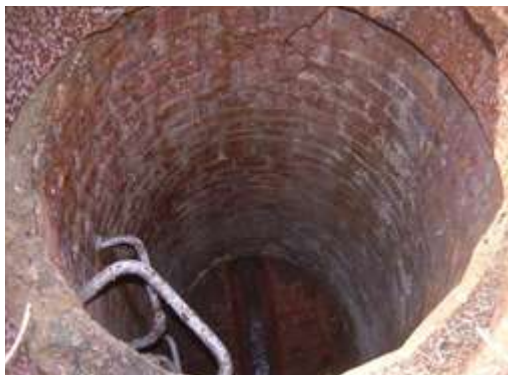
Defect

Frame offset. Adjustment and Corbel root intrusion and infiltration. Barrel infiltration.

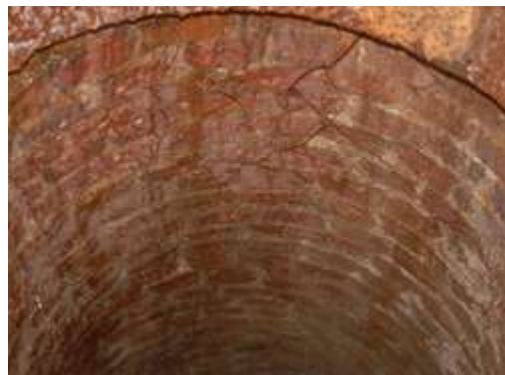
Defect

Adjustment deterioration, root intrusion and infiltration. Corbel root intrusion and infiltration.

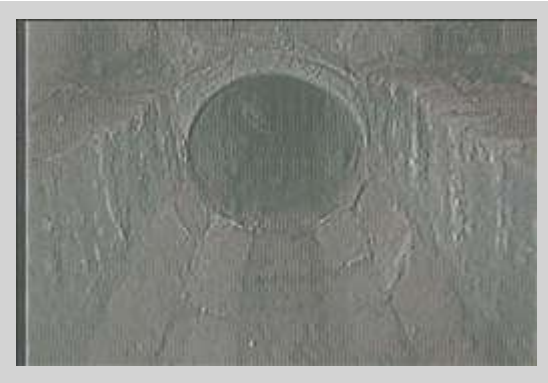
8 in. Circular Gravity Sewer Pipe Out @ 12 O'Clock

Barrel deterioration and infiltration. Channel deterioration.

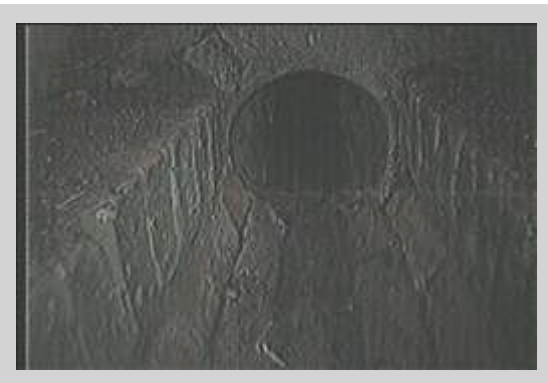
8 in. Circular Gravity Sewer Pipe In @ 6 O'Clock

Barrel deterioration and infiltration. Channel deterioration.
